Architectural, Structural, Mechanical, Electrical,  
and Plumbing Assessment of the Rhinelander  
Highway Shop for the Oneida County Highway  
Department

July 26, 2017

## Oneida County

### Highway Building Assessment

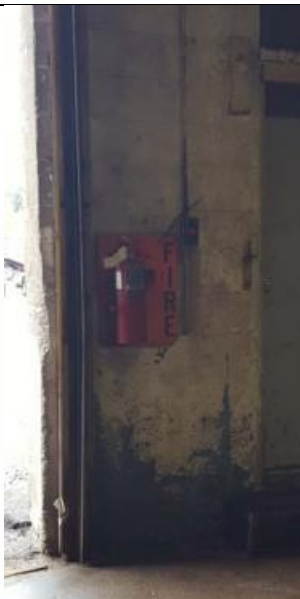
<p>Current codes require location signs above extinguishers. We recommend placing signs at extinguishers in the crew and garage areas so that they can be readily seen around obstructions.</p>

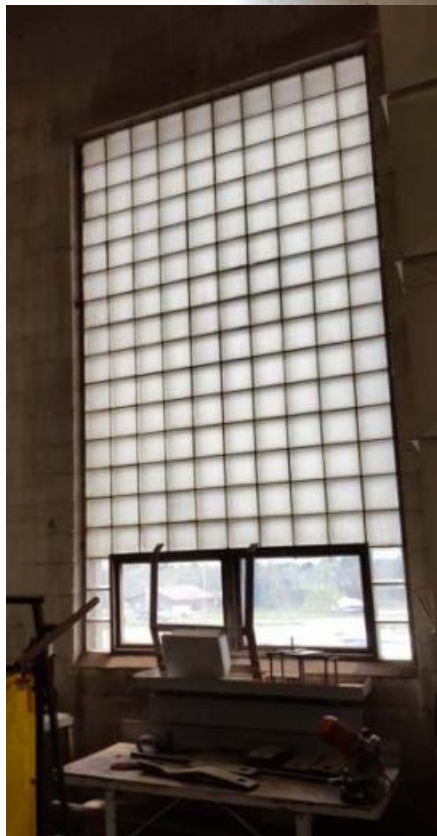
<p>South repair garage has several large glass block fenestrations (6'x12') that have a poor thermal performance (R Values are less than 2). Recommend replacement with insulated glass.</p>

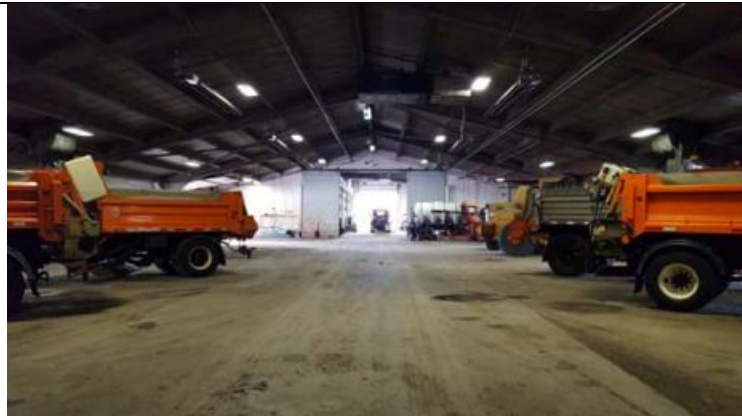
Parking Garage is relatively dry. Lighting is adequate. See electrical comments.

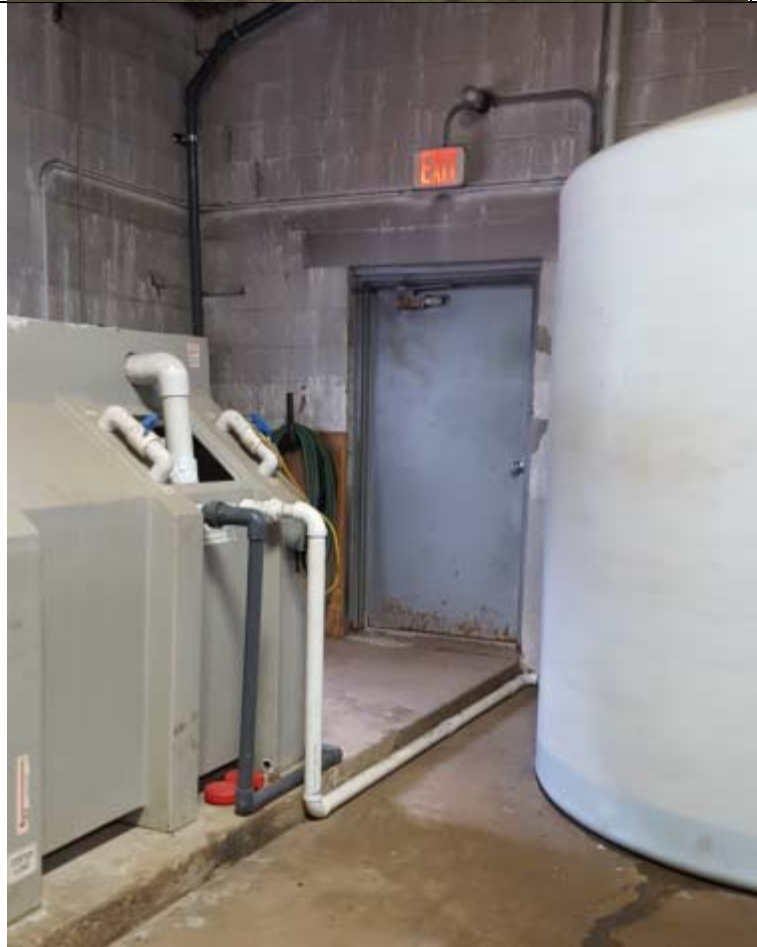
PVC pipe at step at northwest corner of parking obstructs the rules of a stair riser. Recommend extending the concrete step/curb over the pipe with a flush riser to eliminate the tripping hazard.

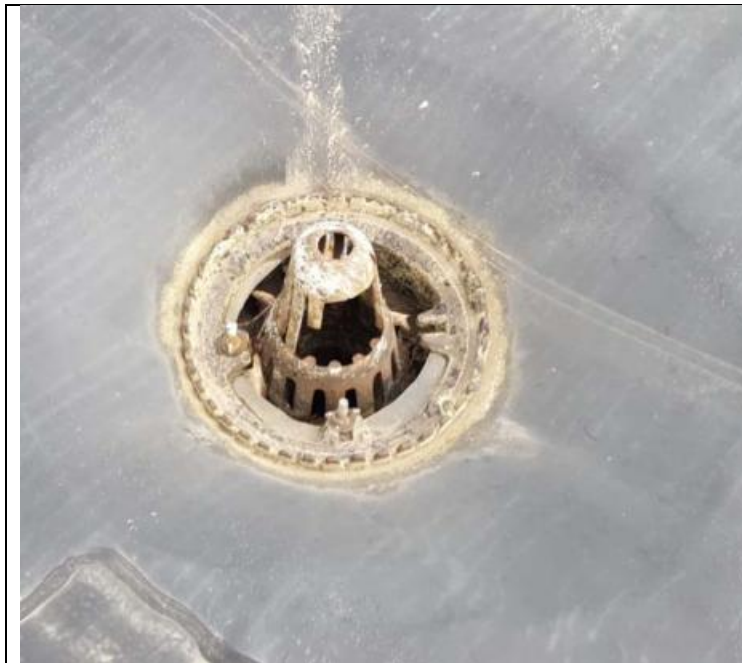
There are 2 old rooftop drains. The one to the northwest has a broken strainer and could be clogged by wind-blown debris. Recommend replacement of these two drains.

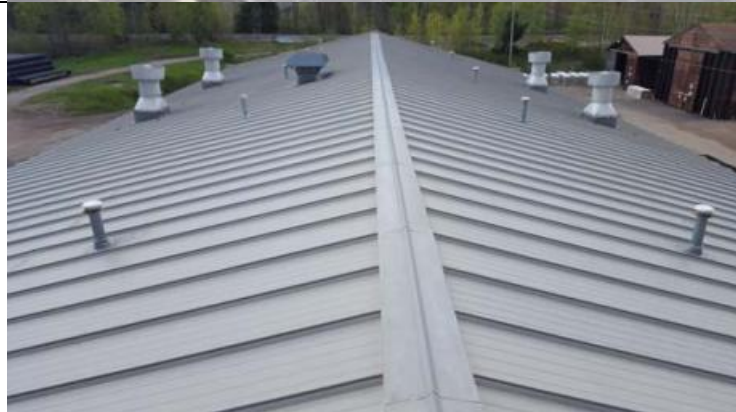
North parking garage metal roof is in good condition. Flashing between this roof and the wall to the south is also in good condition.

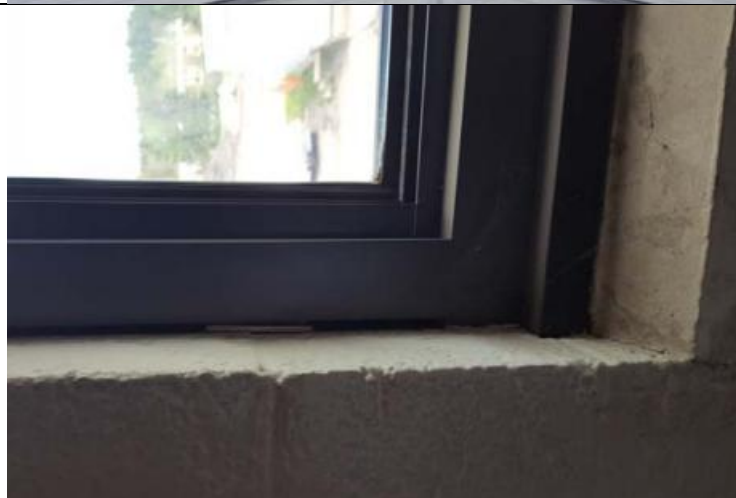
Recommend perimeter sealant at interior side of aluminum windows.

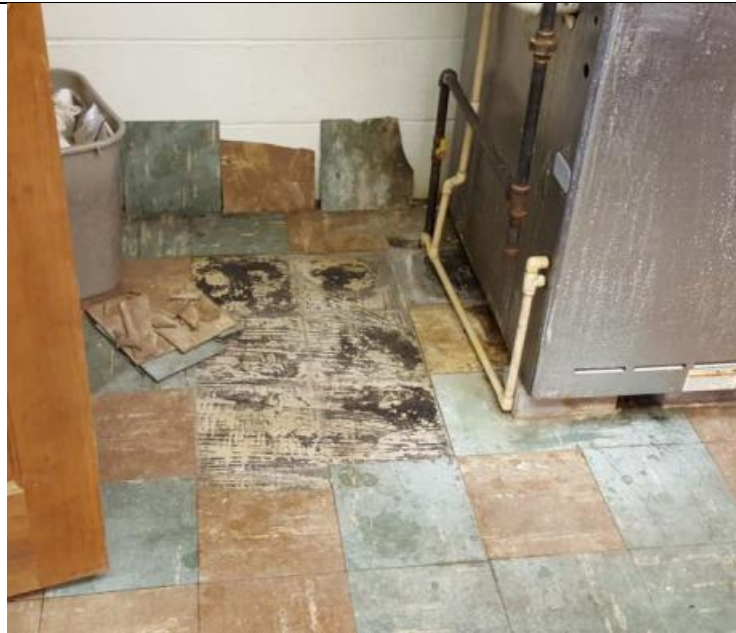
Second floor records room may have asbestos in VCT flooring. Some tiles have come loose or were removed. Tile should be tested and abated/replaced if positive. Asbestos testing company can provide further advice and assistance.

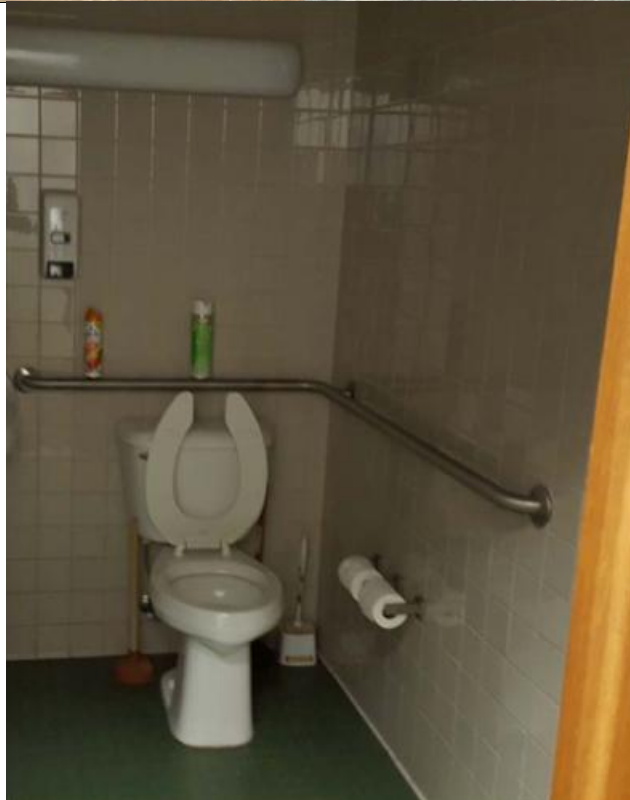
As the administration and reception addition is the only location with accessible toilet rooms, the only accessibility item lacking is a vertical grab bar on the side wall of the toilet. It should be 18" high and located 39"-41" from the back corner and the bottom of the grab bar mounted between 39" and 41" from the finished floor.

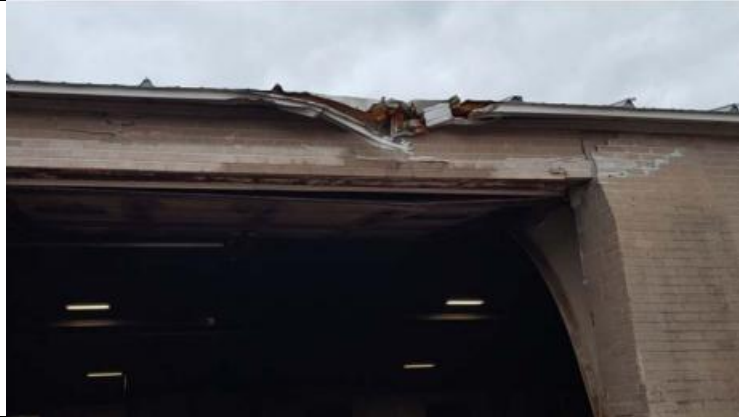
- The eave and wall above the east-facing garage door was damaged by a vehicle hit. It appears that the damage is non-structural, but the area should be repaired to avoid accelerated deterioration of the building.

Extensive roof eave and block damage. Repair is needed, but the wall damage is not structurally critical.

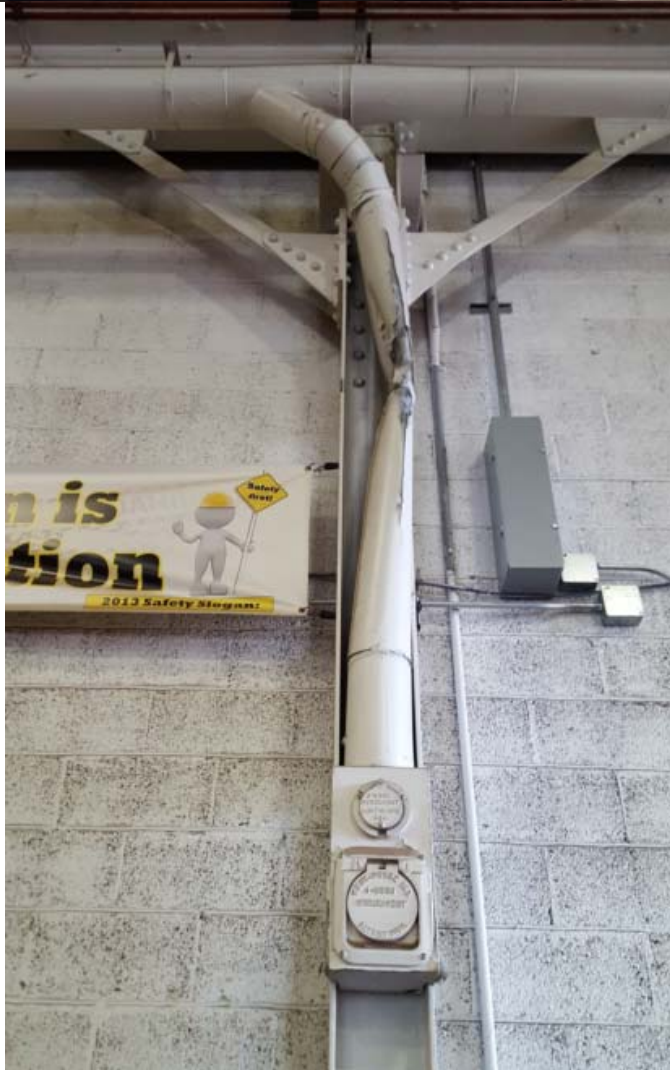
Exhaust fan ports are damaged throughout Repair Garage. See mechanical evaluation.
